Attachment 9- Architectural Preservation

This Attachment details the efforts made to preserve select architectural elements for later heritage interpretive reuse, covering three areas of interest:

1.1 Portico Deconstruction Work

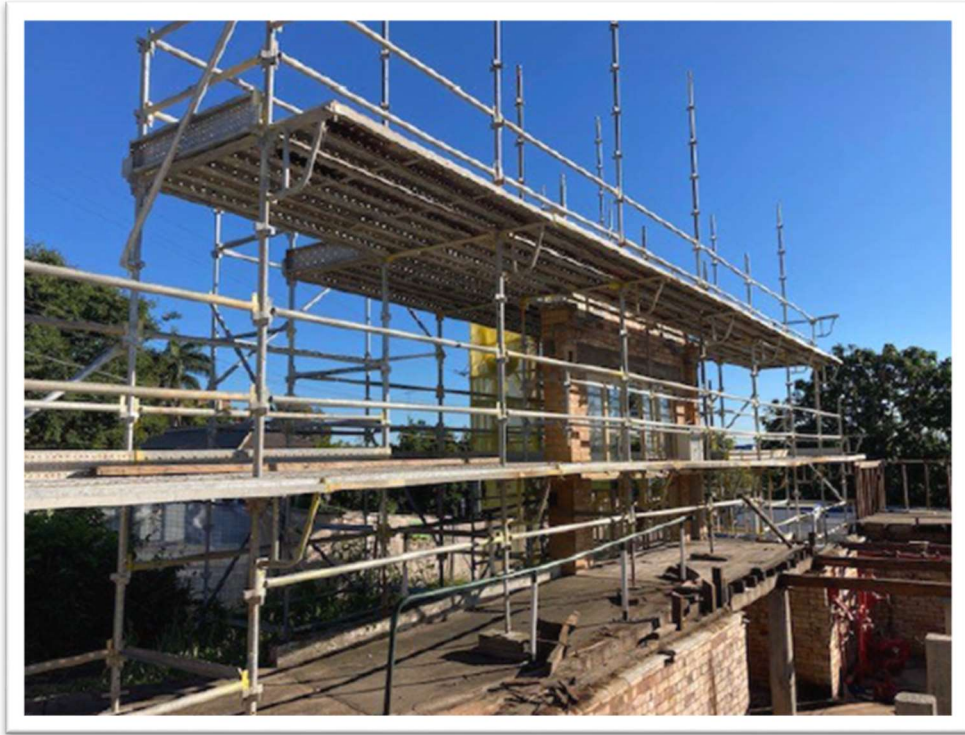
Figure 6. PORTICO SCAFFOLDED AND READY FOR DECONSTRUCTION.

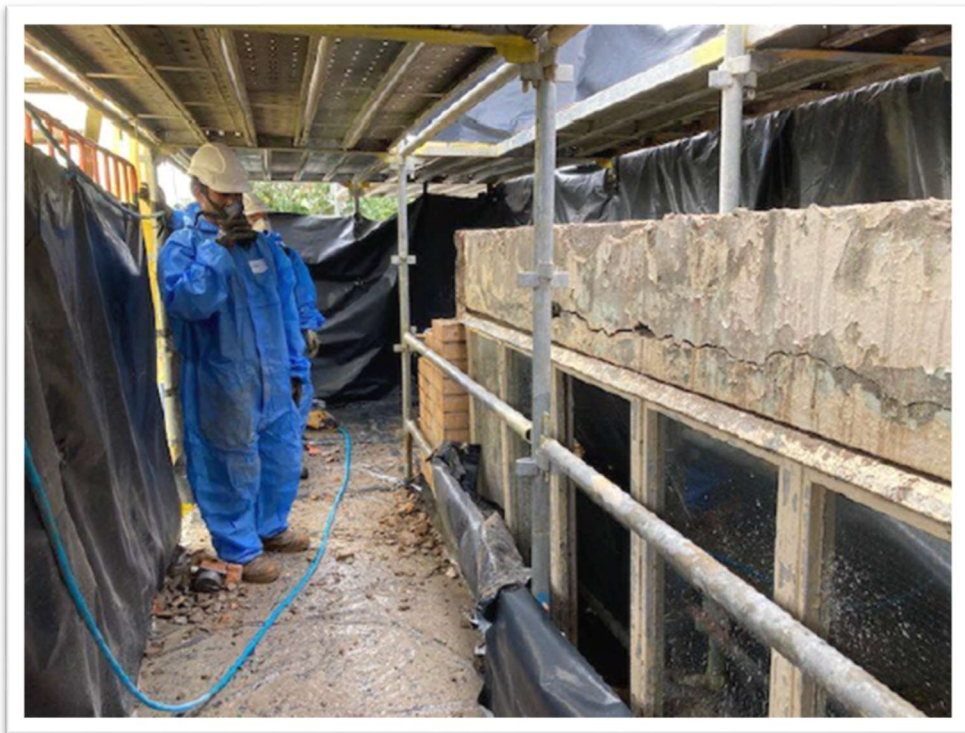
Figure 7. BRICK PORTICO RECOVERY WORKERS IN RPE (P2/P3 HALF FACE) AND TYPE 5/6 DISPOSABLE COVERALLS DUE TO SILICA DUST RISK.

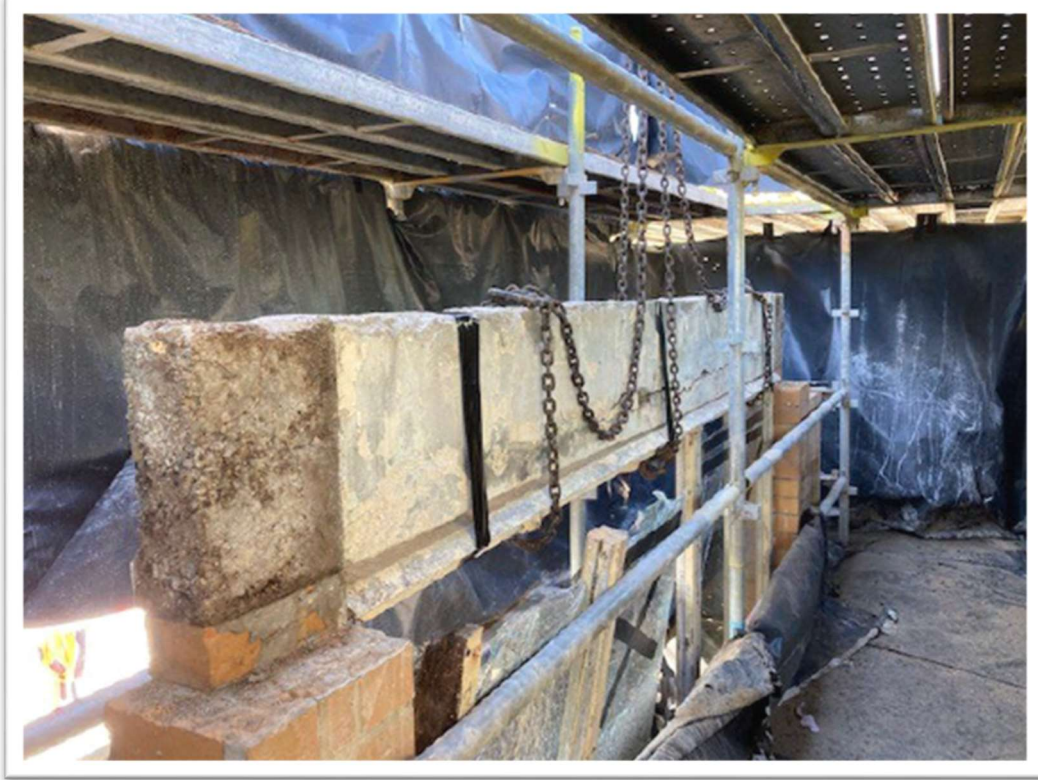
Figure 8. PORTICO LINTEL READY TO BE HOISTED CLEAR INTACT

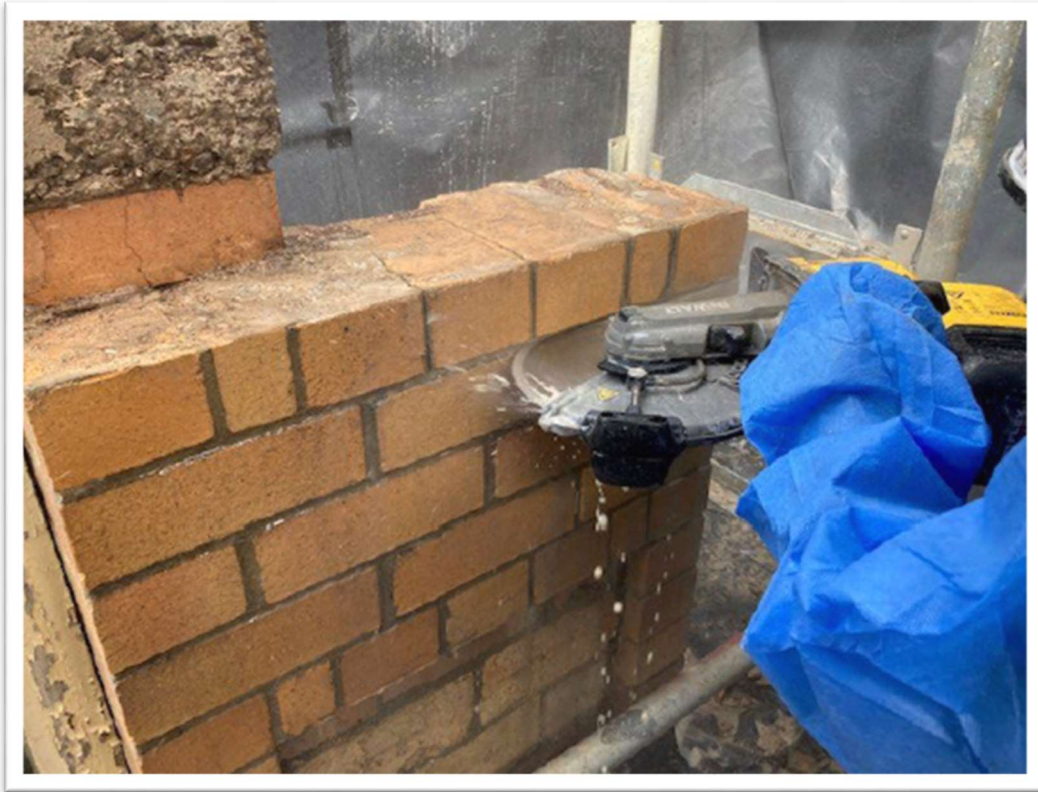
Figure 9. CEMENT BASED MORTAR (SILICA) BEING CAREFULLY REMOVED USING A WET SAW TO PRESERVE THE HERITAGE BRICKS FOR RECONSTRUCTION OF PORTICO.

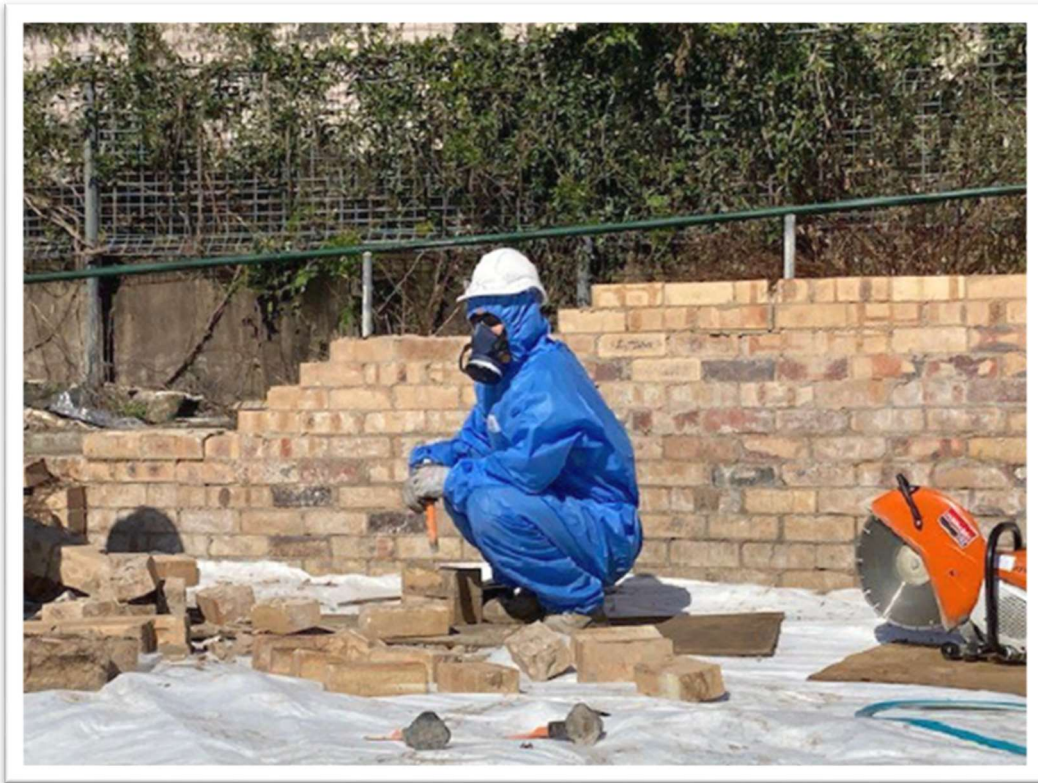
Figure 10. PIECEMEAL SEPARATION AND CLEANING OF DECONSTRUCTED PORTICO BRICKS

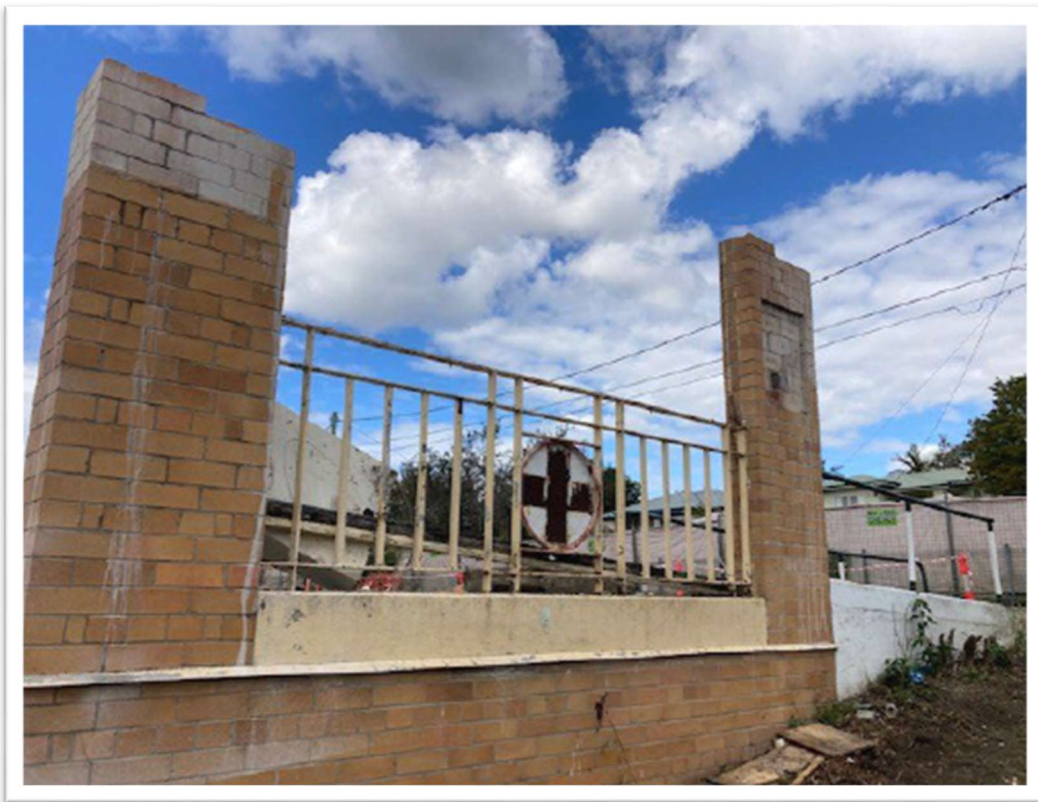
Figure 11. REMAINING PORTICO FOLLOWING THE SALVAGE OF THE HEAD STOCK BRICKWORK AND THE REMOVAL OF THE ACCESS SCAFFOLDING.

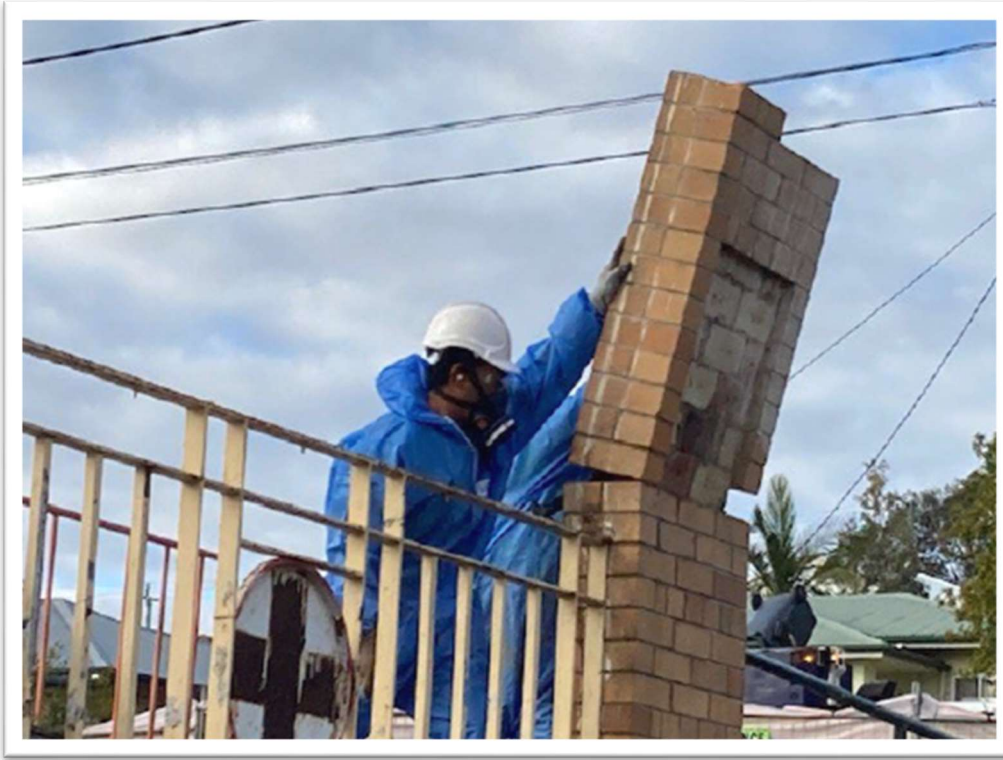
Figure 12. CONTROLLED SEPARATION OF THE BRICK COLUMNS. THESE SECTIONS WERE SEPARATED BY A HORIZONTAL “WET” SAW CUT UNDER SILICA CONTROLLED CONDITIONS AND MANUALLY DIRECTED ONTO SOFT SOILS FOR FURTHER BRICK SEPARATION AND SALVAGE.

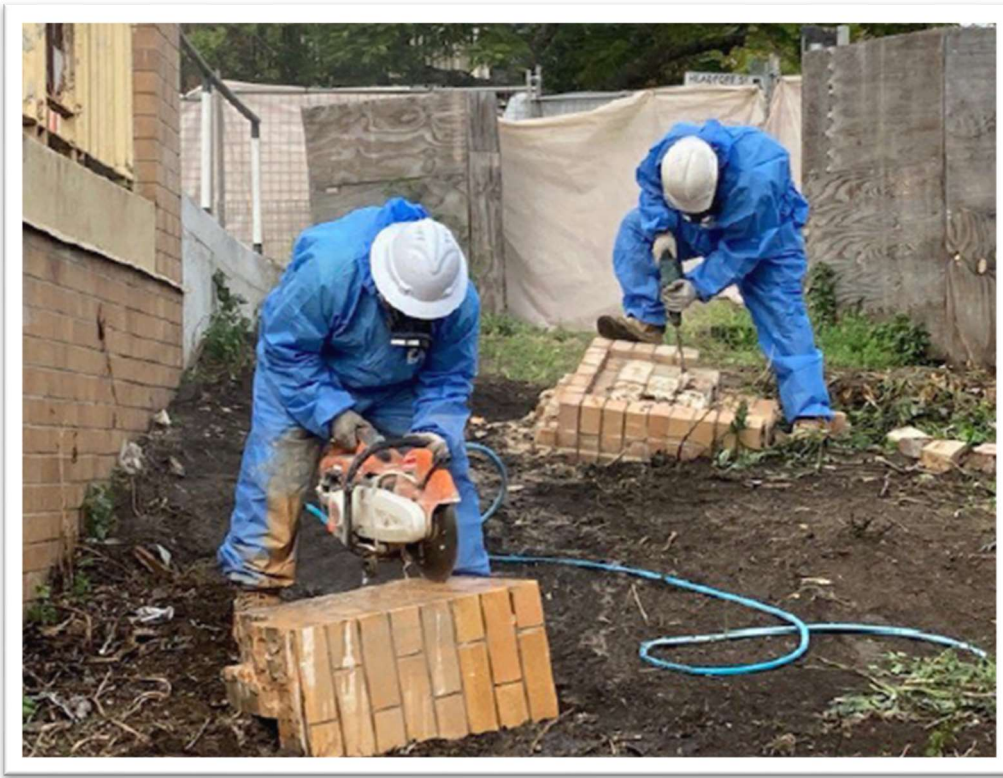
Figure 13. “WET” SAW & MANUAL SEPARATION METHODOLOGY OF THE BRICK COLUMN SECTIONS.

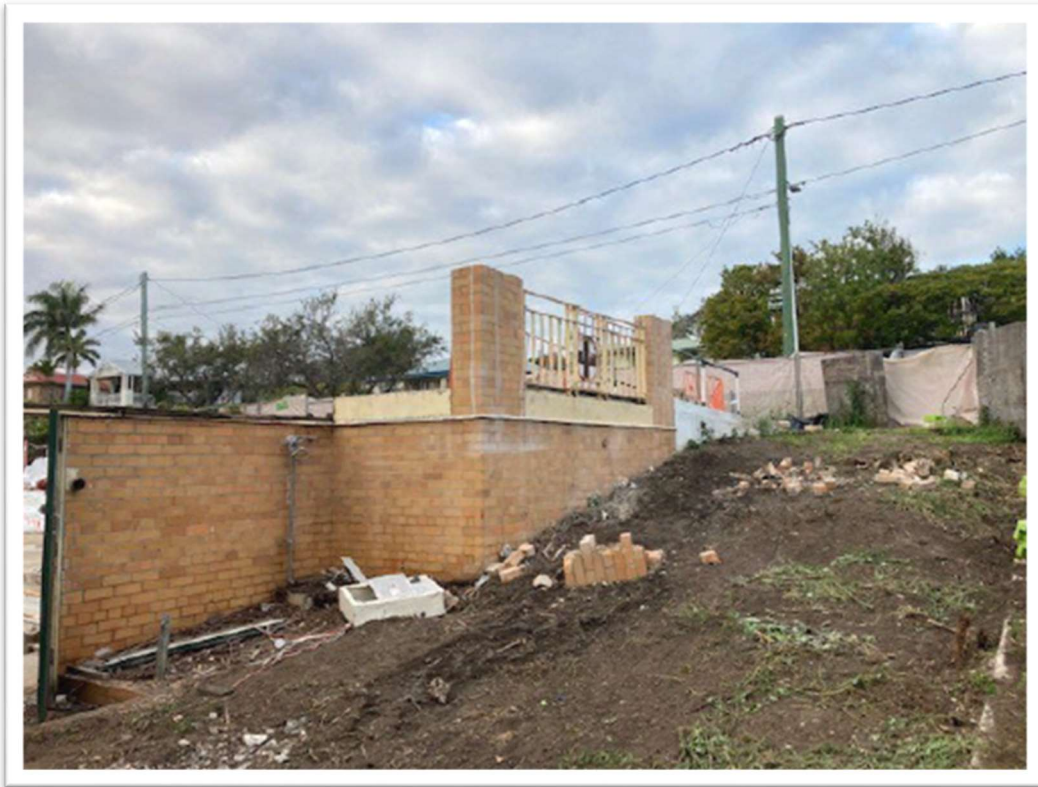
Figure 14. THE REMAINING PORTICO STRUCTURE, YET TO BE SALVAGED.

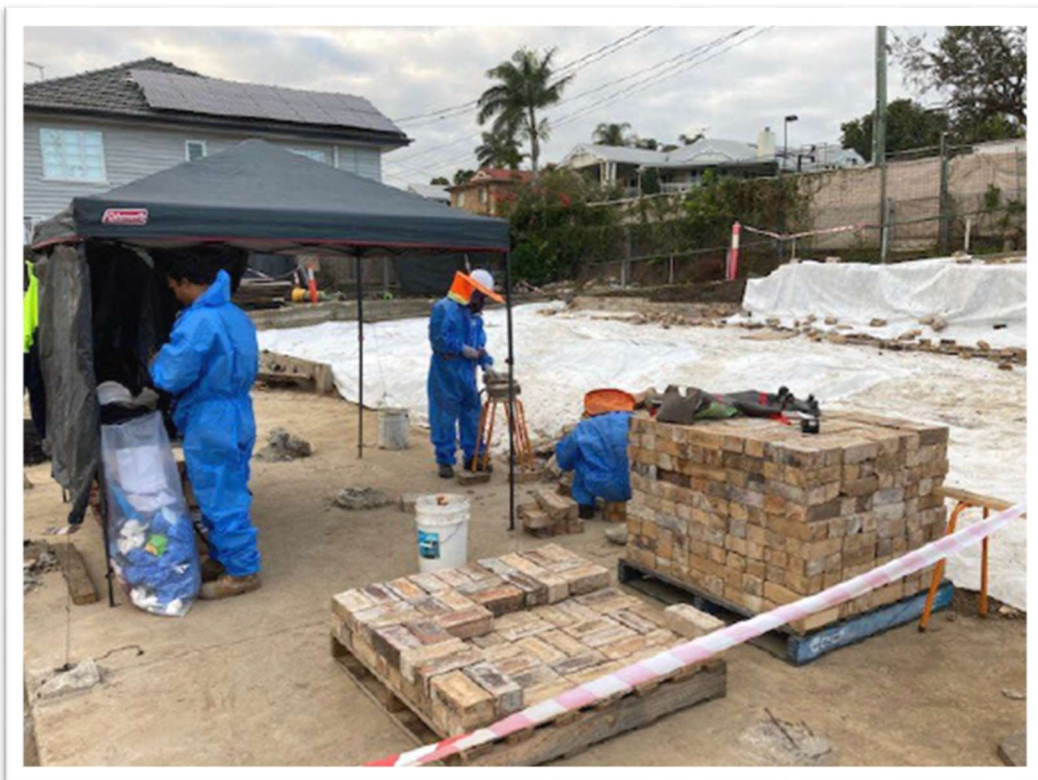
Figure 15. MANUAL CLEANING / RECOVERY PROCESS OF THE HERITAGE LIST BRICKS THAT WILL BE RE-USED IN INTERPRETIVE HERITAGE STRUCTURE IN PARK

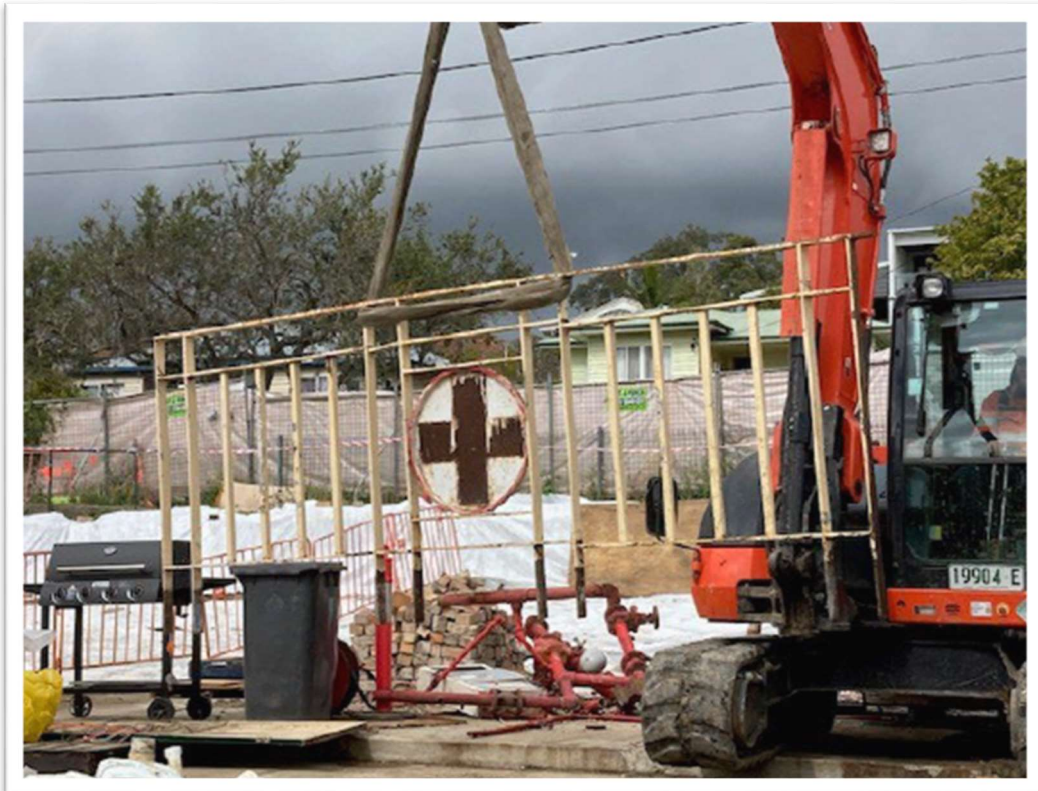
Figure 17. SALVAGE OF THE OLD MAIN HALL PORTICO BALUSTRADE READY FOR STORAGE

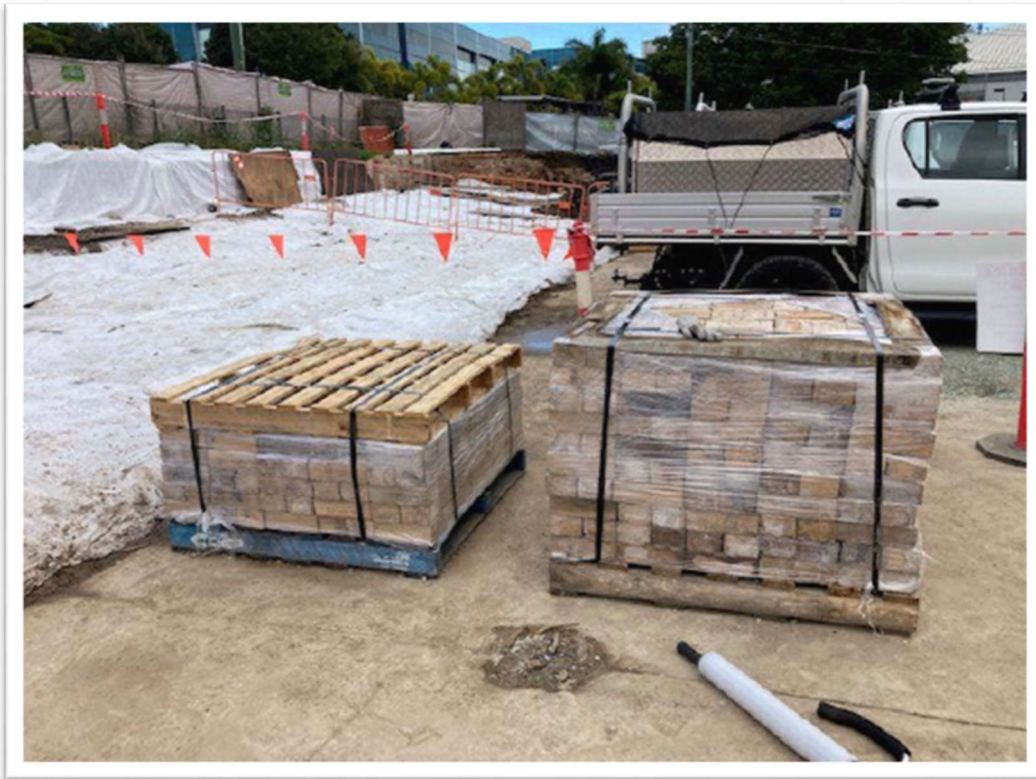
Figure 18. RECOVERED PORTICO BRICKWORK, CLEANED OF MORTAR, AND PALLETISED READY FOR STORAGE.

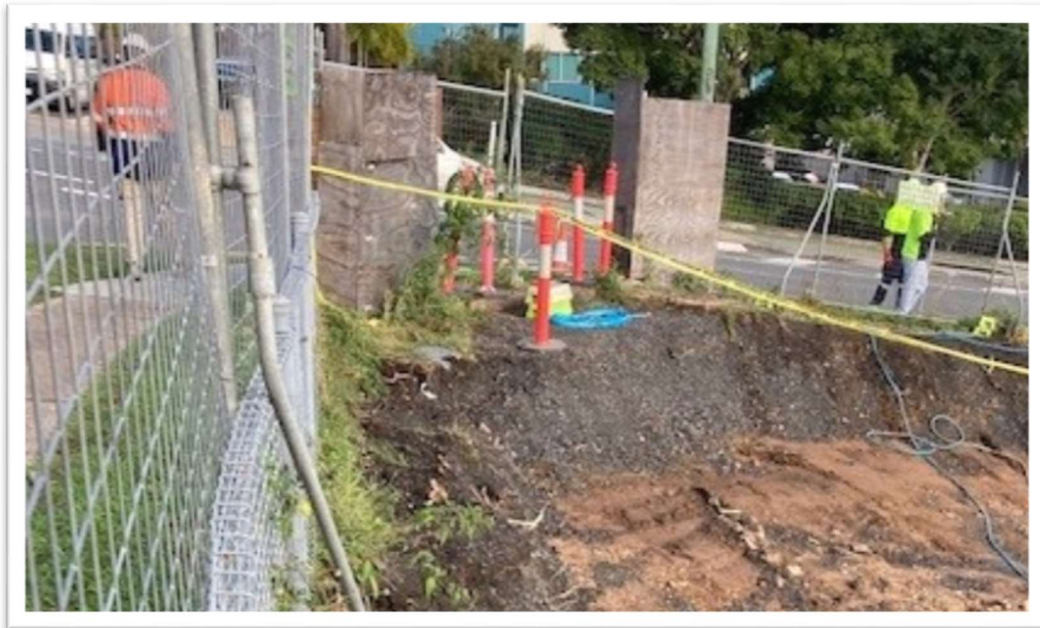
Figure 24. ENTRY GATES PROTECTED BY PLYWOOD HOARDINGS DURING NEARBY EXCAVATION WORKS

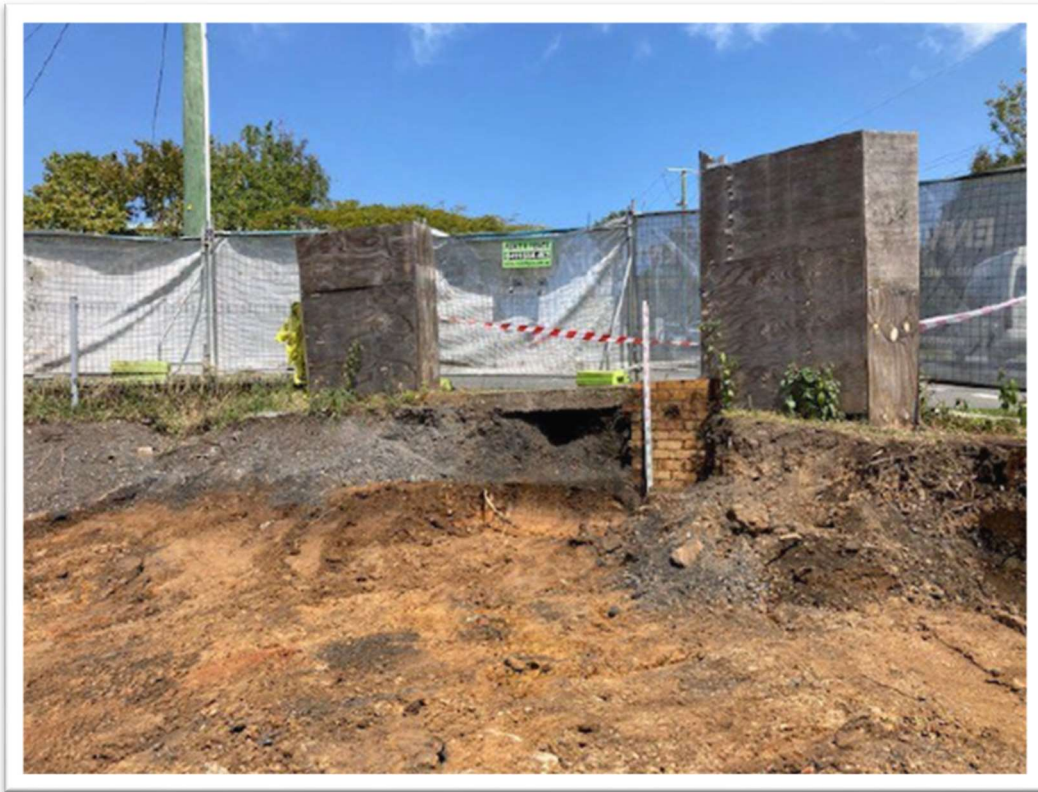
Figure 25. GATE PROTECTED BY PLYWOOD HOARDING

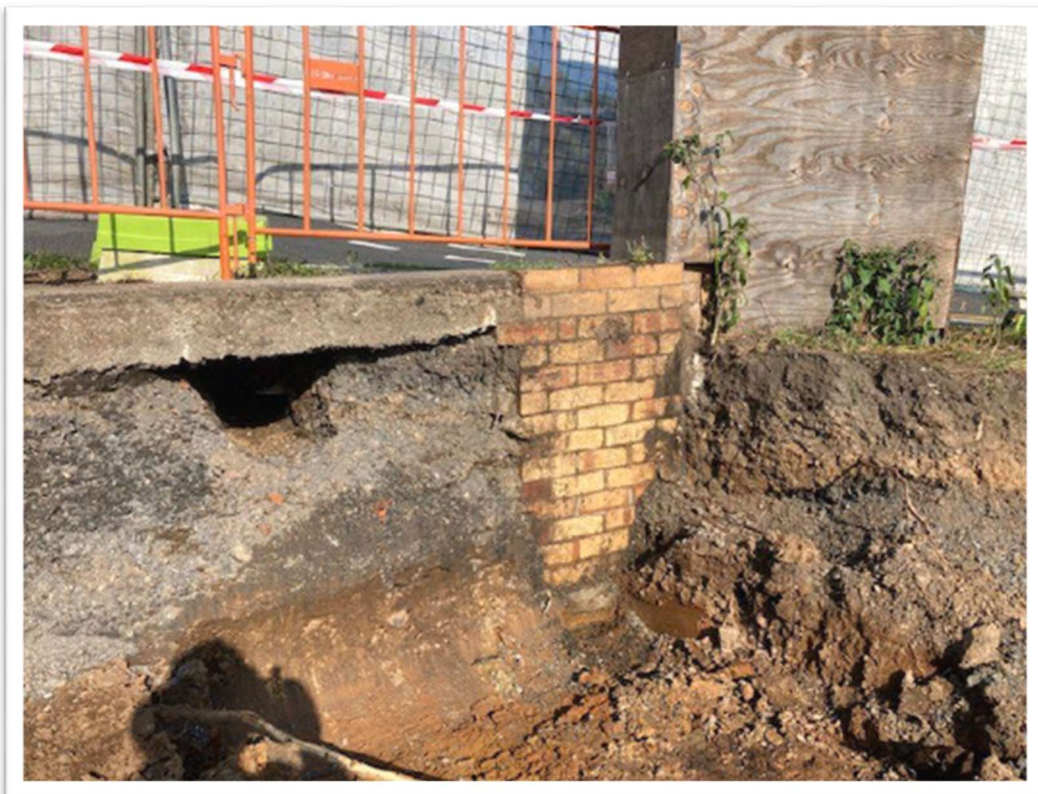
Figure 26. PLYWOOD HOARDING AND SUB SURFACE BRICK AND CONCRETE FOUNDATIONS OF GATES PRESERVED

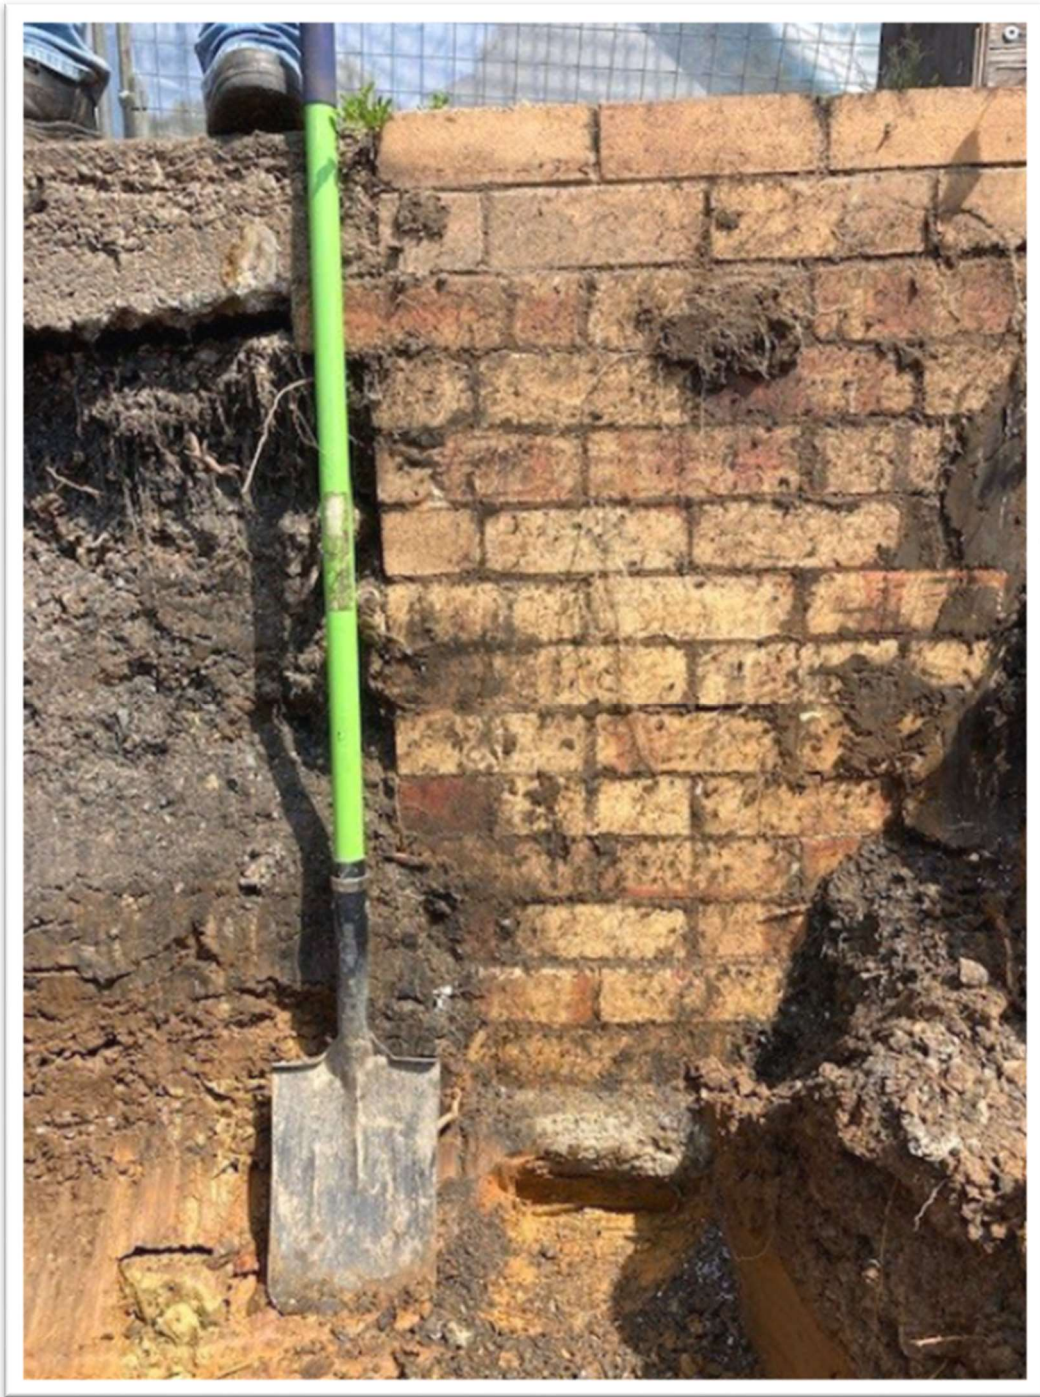
Figure 27. GATE FOUNDATIONS – BRICK ON 100MM CONCRETE SLAB (ALL SUB-SURFACE)

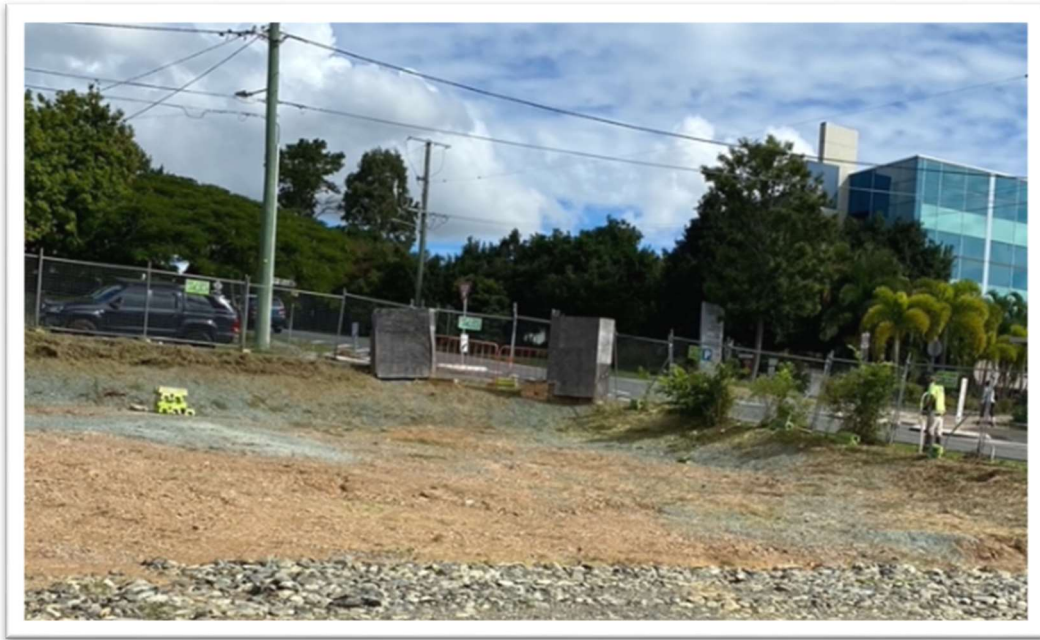
Figure 28. POST REMEDIATION – PLYWOOD HOARDING RETAINED FOR ONGOING PROTECTION OF GATES

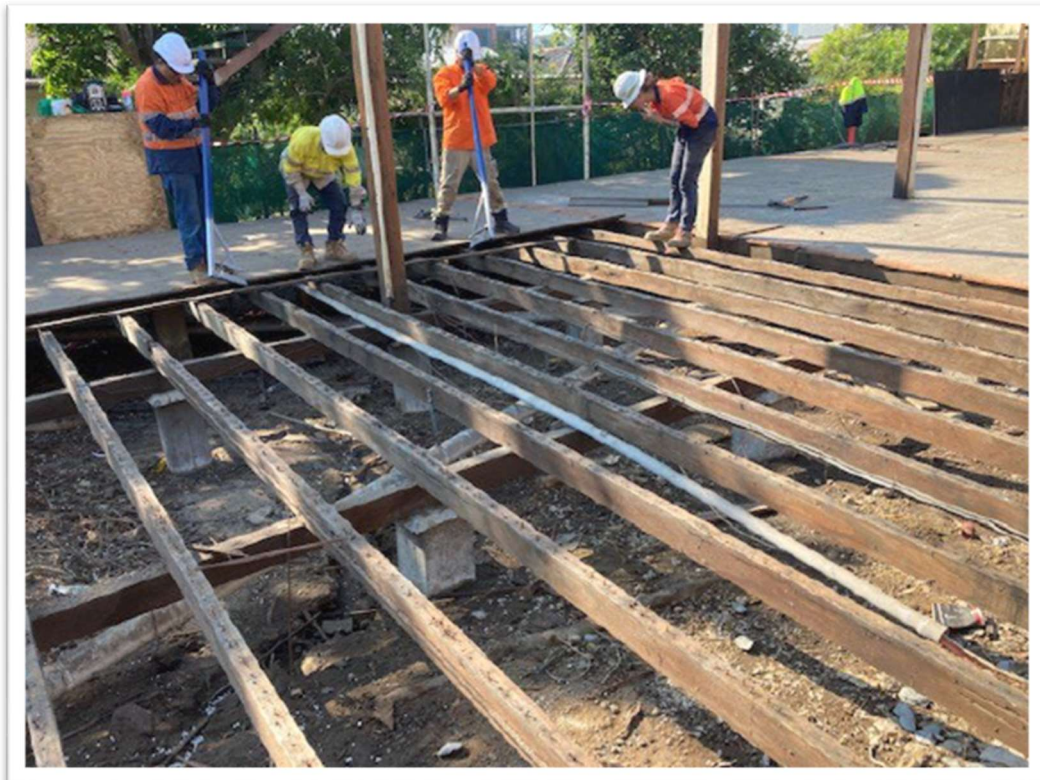
Figure 29. SALVAGE OF HARDWOOD FLOORBOARDS FOR INTERPRETIVE RE-USE IN LEGACY HOUSE AND COMMUNITY PARK

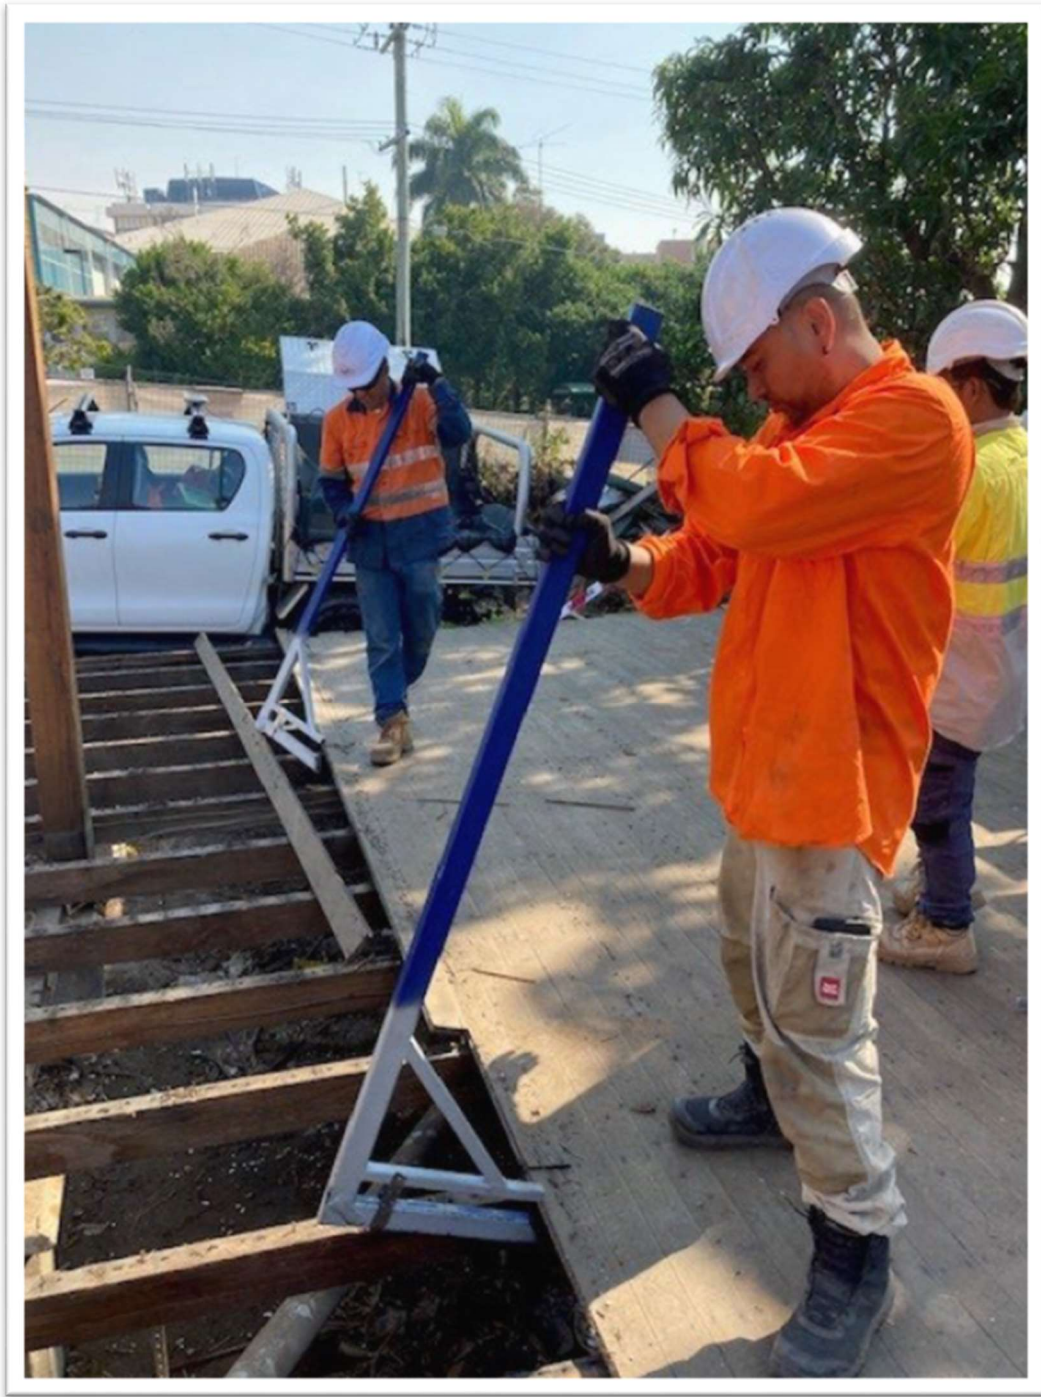
Figure 30. NON-DESTRUCTIVE METHOD OF FLOORBOARD RECOVERY

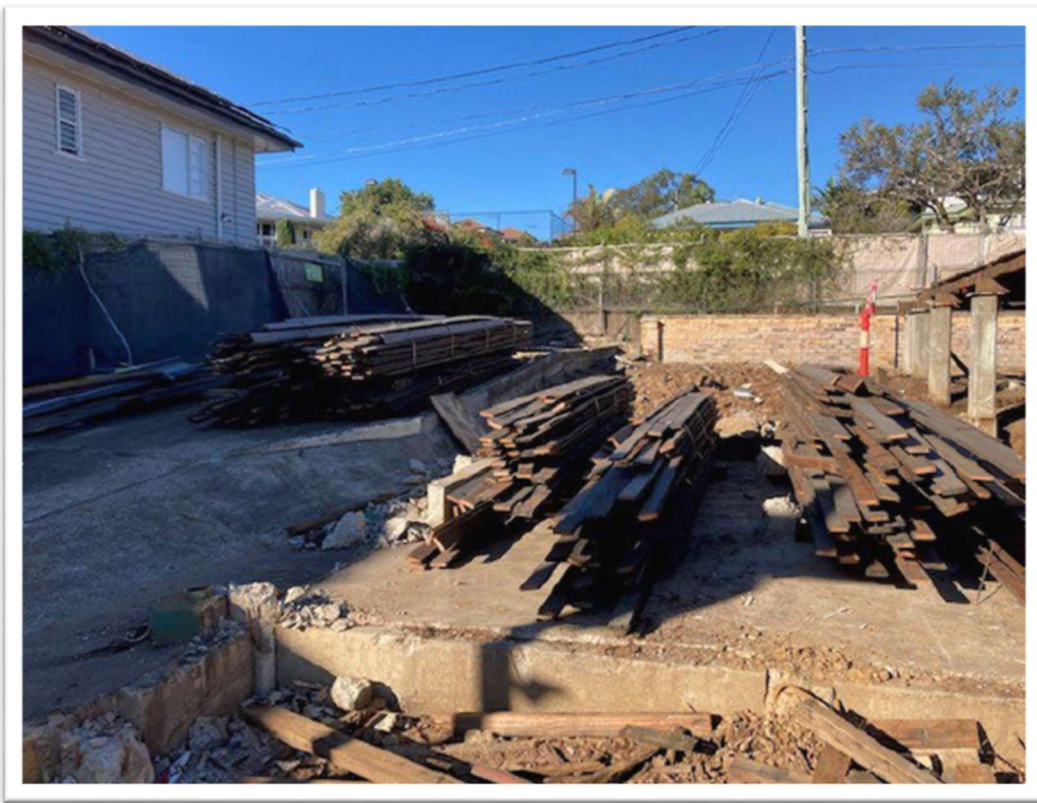
Figure 32. SALVAGED FLOORING TIMBER FOR RE-USE IN LEGACY HOUSE, READY TO BE DE-NAILED

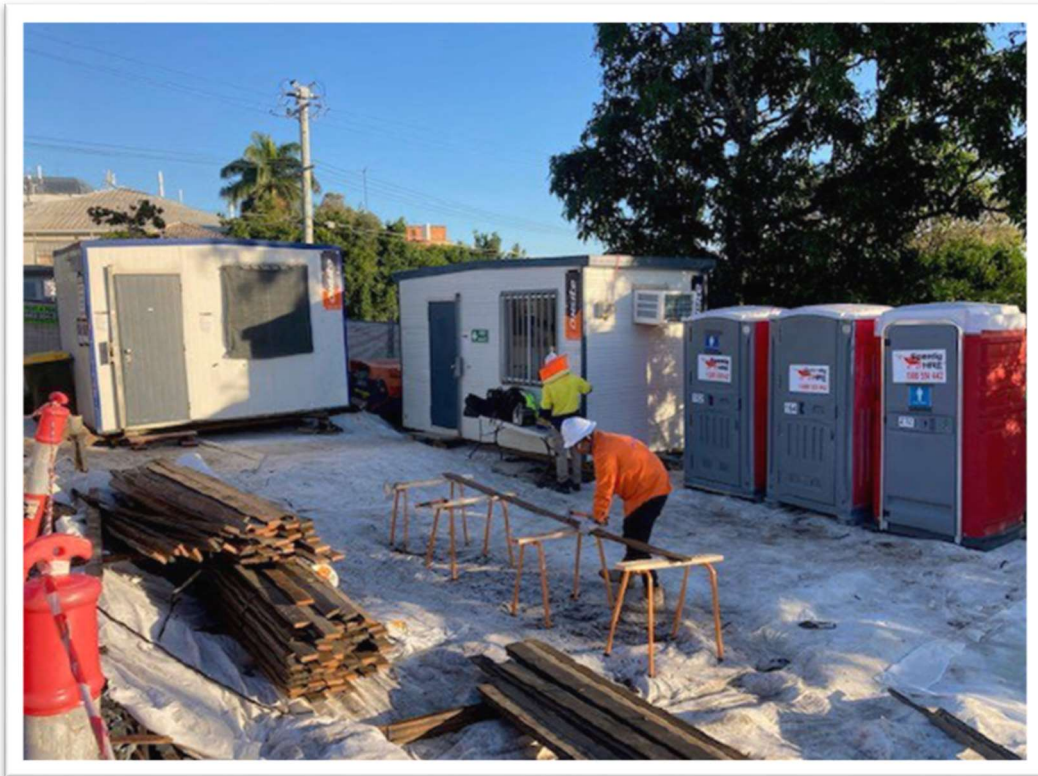
Figure 33. DE-NAILING OF SALVAGED FLOORING.
